Major Training Clip Lock Roof

Stage 1 - Supply & Install Stage 2 - Supply

VersEseal Rapid Build & VersEseal Top Coat

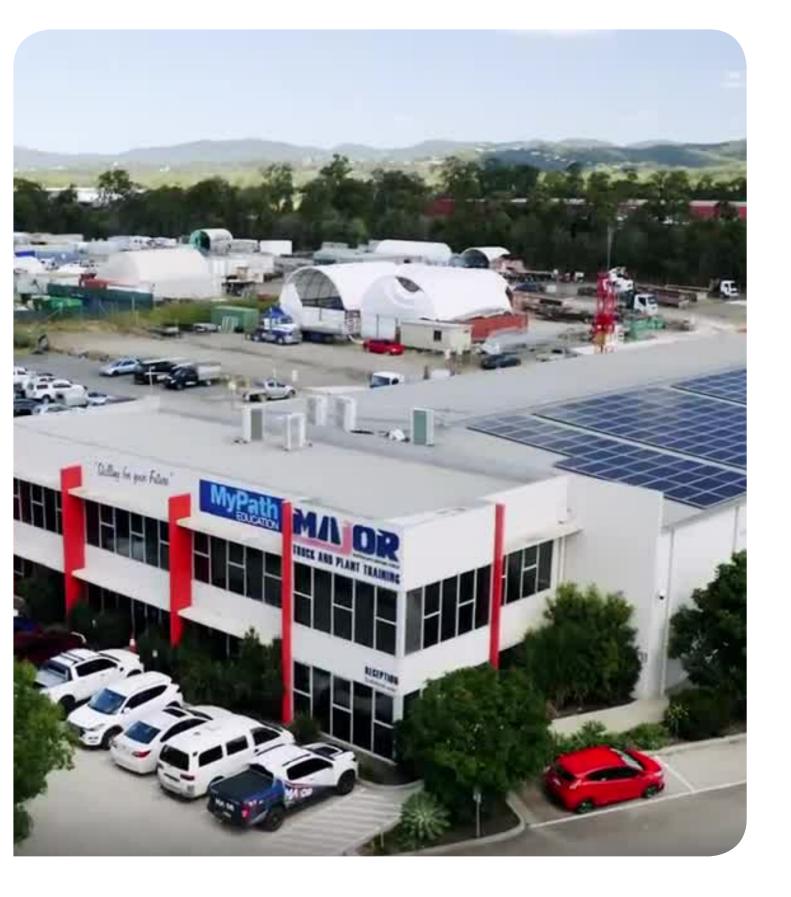
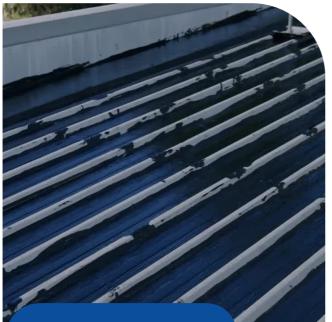
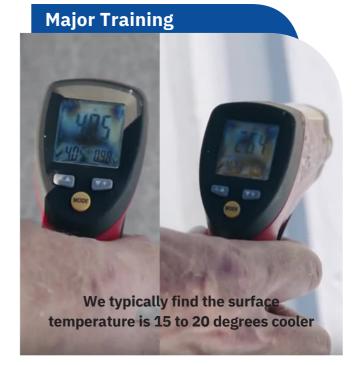
The metal Clip Lock roof was afflicted by numerous leaks, primarily around the problematic box gutter and its junction with the wall. Additionally, leaks were detected around vent pipes, along various joints, and at points where equipment had been affixed to the roof. These issues had resulted in extensive damage to the suspended ceiling inside.

Our skilled applicators applied VersEseal's premium waterproofing membrane due to its exceptional adhesive properties, creating an impenetrable barrier against moisture intrusion. The membrane's comprehensive leak protection ensured meticulous sealing at vulnerable points, guaranteeing long-term effectiveness, while its flexibility and durability accommodates structural movements and temperature fluctuations for lasting performance.

The final touch on this project involved the application of VersEseal Top Coat in white. This not only improved the roof's visual appeal but also brought about a substantial reduction in surface temperature compared to the conditions before its application. By reflecting sunlight and decreasing heat absorption, the Major Training Roof now offers a more thermally balanced environment.
